## Mainland Enhancement of Salmonoid Species Society

M.E.S.S.S. Report - Rotation 7  
DFO Area 12 Stock Assessment 2024

Enumeration Period: October 17 - October 24, 2024

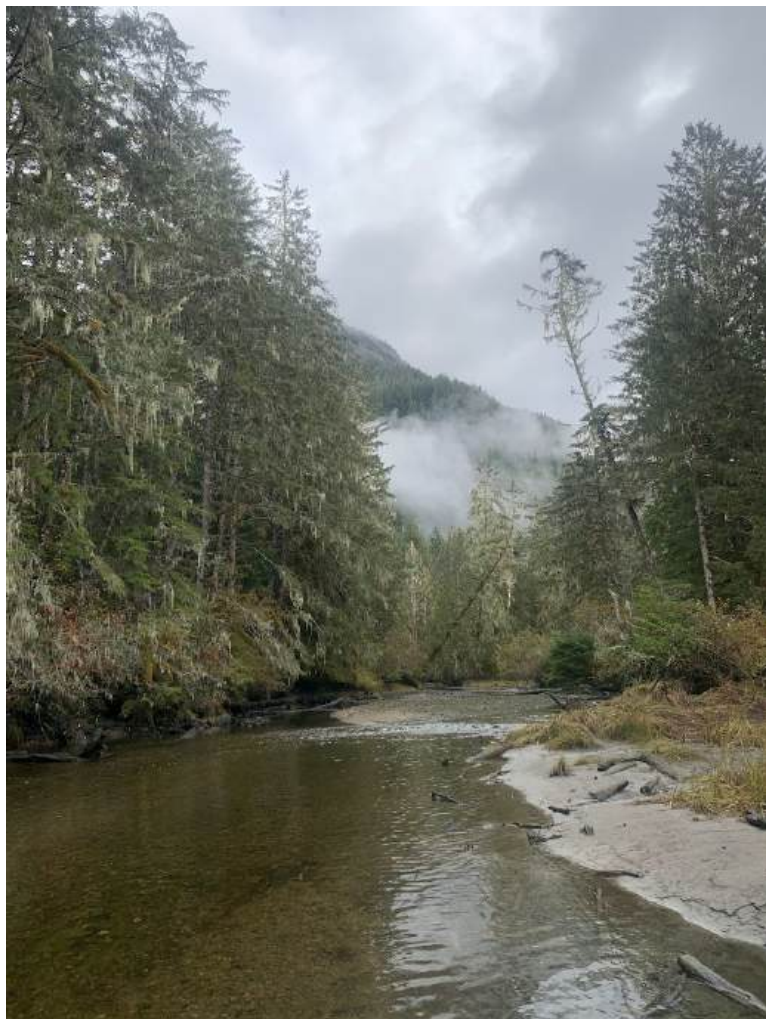
Photo 1 – Clear water and autumnal vibes in the Hada side channel.

- Excellent surveying conditions compared to other streams, low clear water.
- Decrease in spawning and spawned out fish seen.
- Streambed movement and changes to general river morphology due to high flows.
- Coho still holding and not spawning.

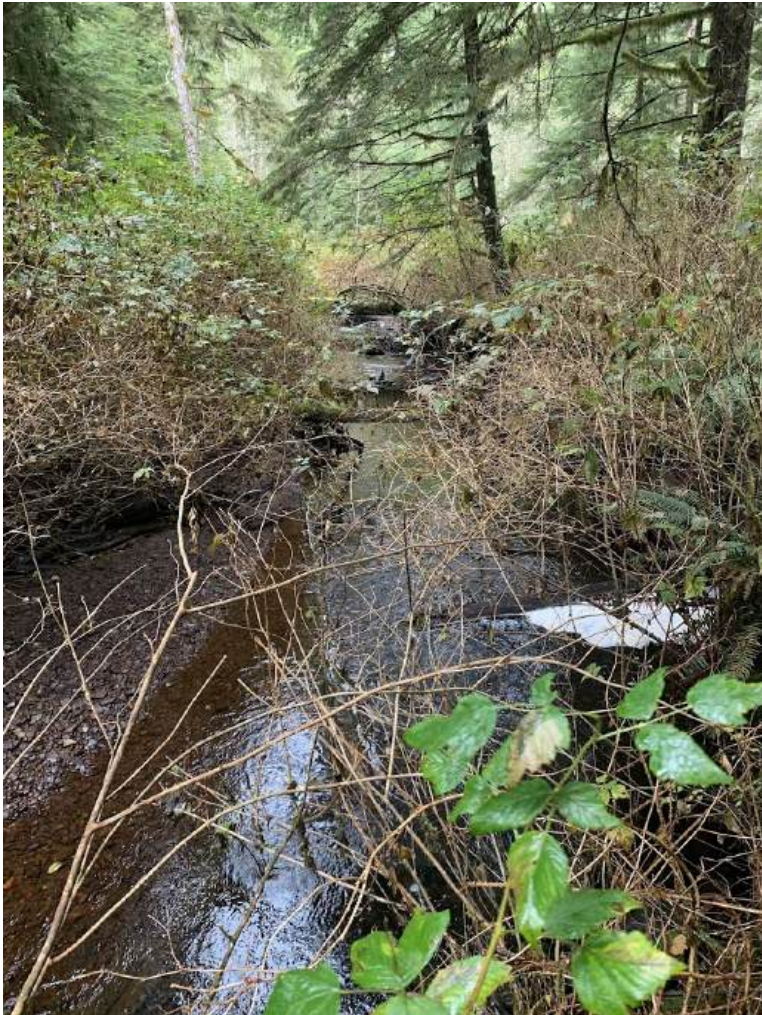
Photo 2 - Water levels in Wahkana Bay Creek.

- No fish seen.
- Improved surveying conditions now that the system has flushed.
- High water mark from rain event increased flows 3ft (500%).

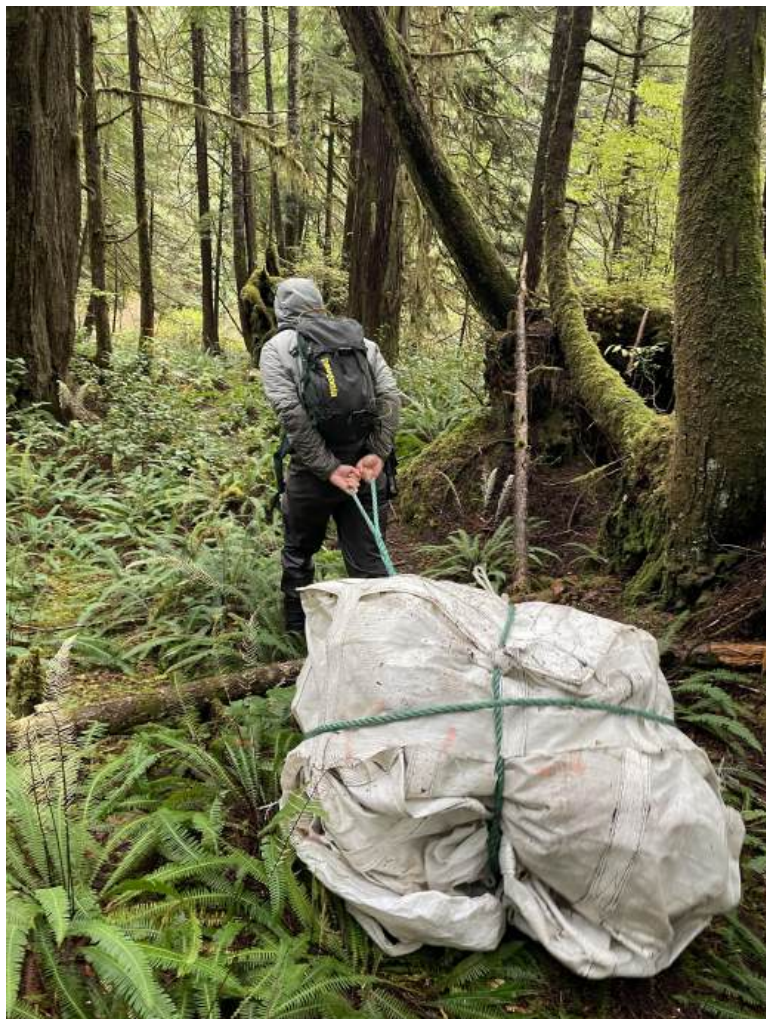
Photo 3 - Hauling out last of gravel addition bags (go Ian!)

- Slightly lower water levels than previous survey.
- Dead pinks encountered, washed up and dried on banks.
- Flat light and dark sections made for poor visibility.
- Removed last of gravel addition bags.

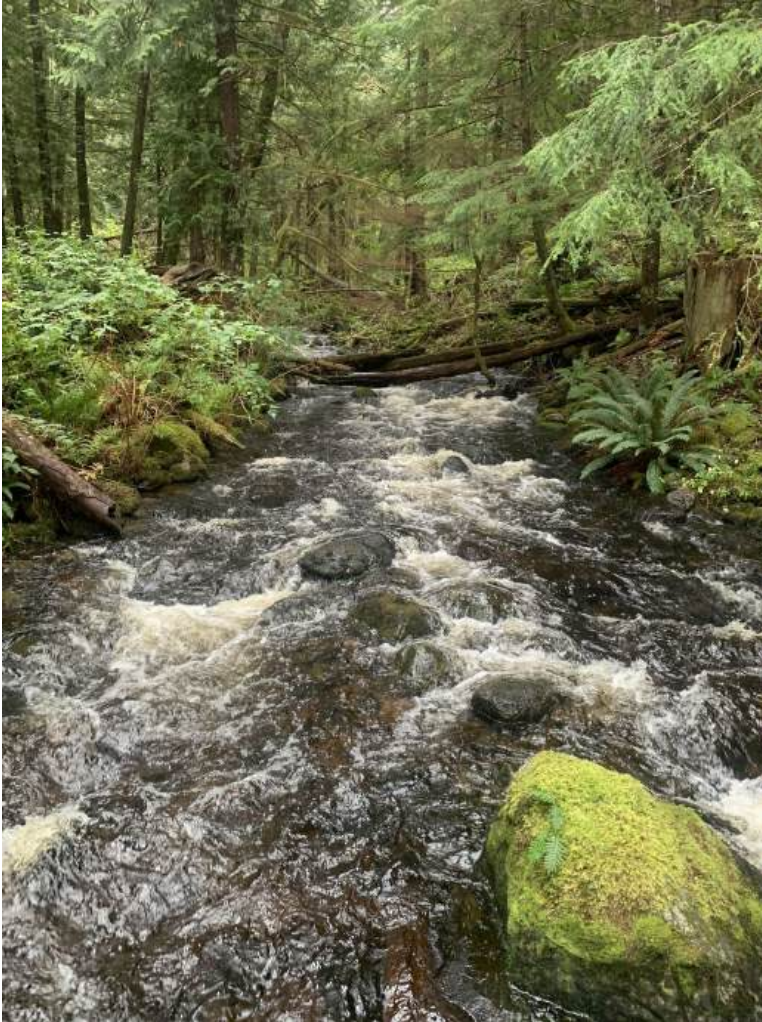
Photo 4 – Fast water throughout Carriden Bay Creek made for difficult wading and surveying.

- Continued high stream levels.
- Large sections of whitewater made surveying conditions poor.

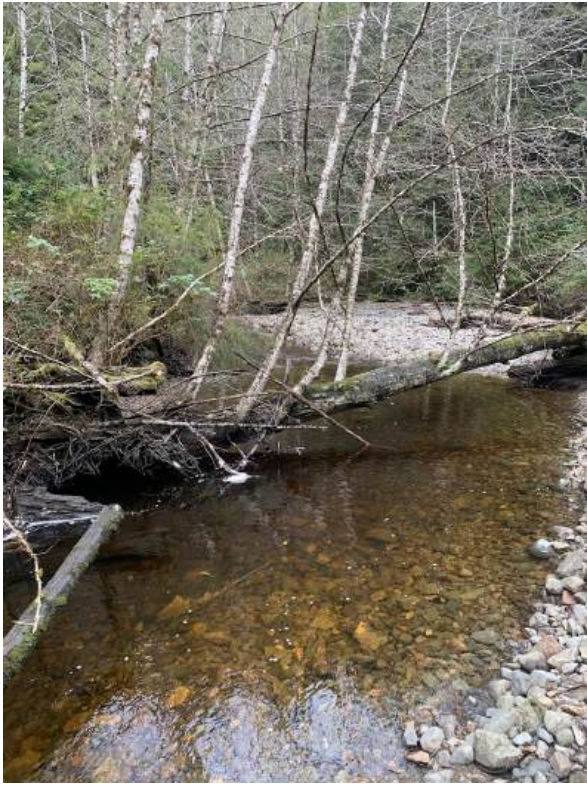
Photo 5.1 – The biosample pool in Viner.

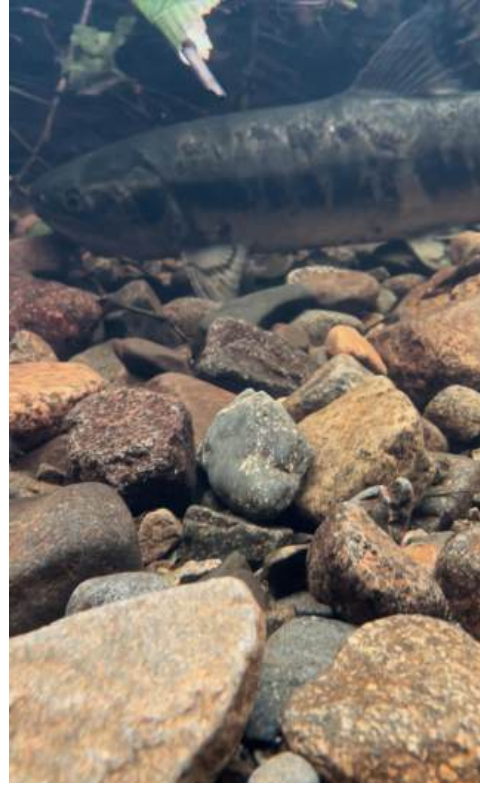
Photo 5.2 - A female chum spawning in Viner.

- Large decrease in numbers of chum seen in system.
- High water likely pushing post spawn fish out of the river.
- Fresh spawning fish seen in lower 300m of river.

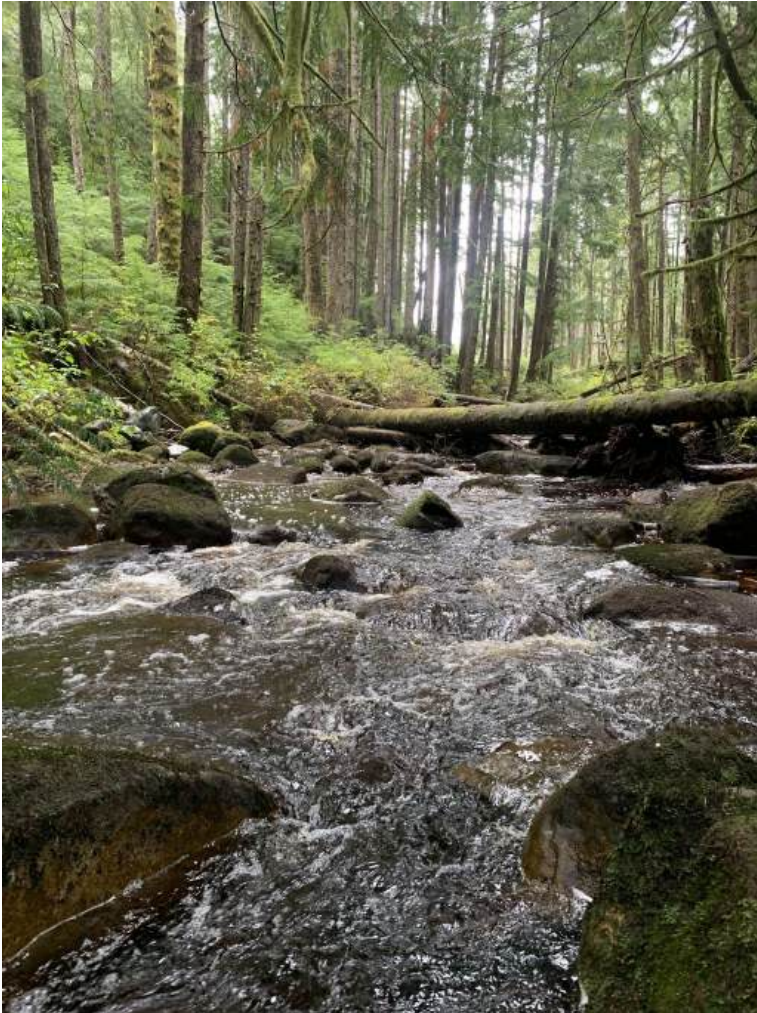
Photo 6- Water levels at the biosampling rock in Shoal Harbour..

- Chum largely spawned out and hiding in stream.
- One coho seen moving up lower part of Shoal.

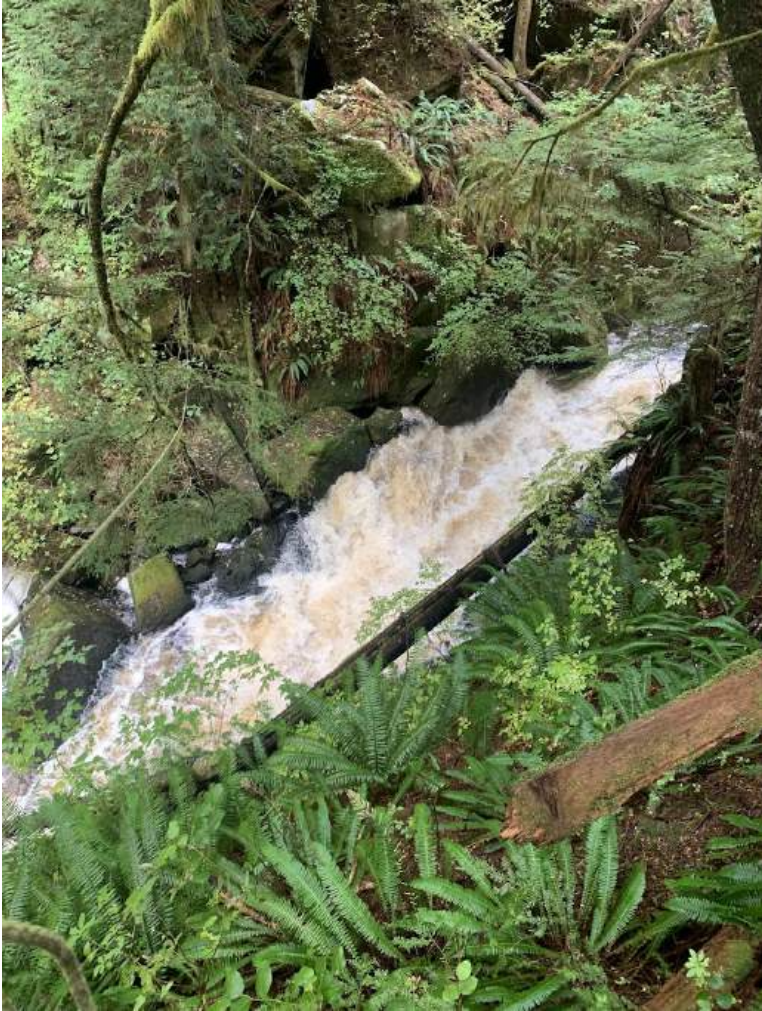
Photo 7– High water levels at the lower falls.

- 9 adults and 6 jacks observed jumping at 1.5 kilometer falls during 20 minute jumper count.
- Decrease in fish activity at falls as the coho spawn in the tributaries begins.

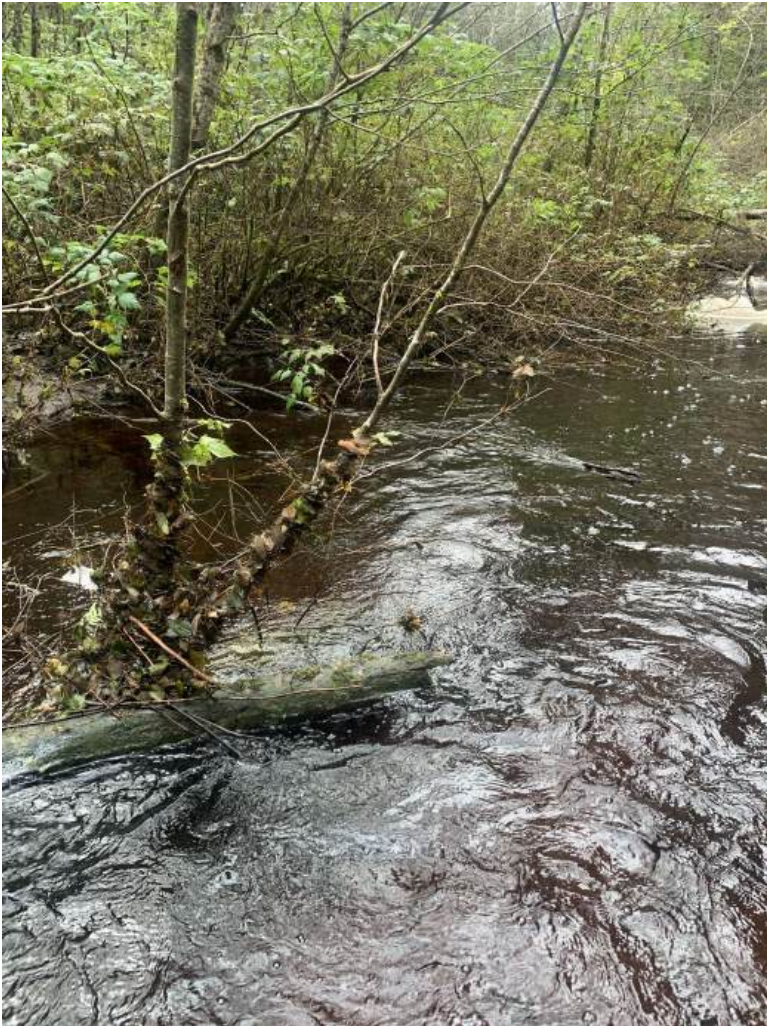
Photo 8 - High water marks showing where the stream levels the stream reached after last weeks rain event.

- Continued high flows resulted in low survey visibility and confidence.
- High water mark was 3.5ft higher than regular flows (400% increase).
- Coho likely moving through system with ease.

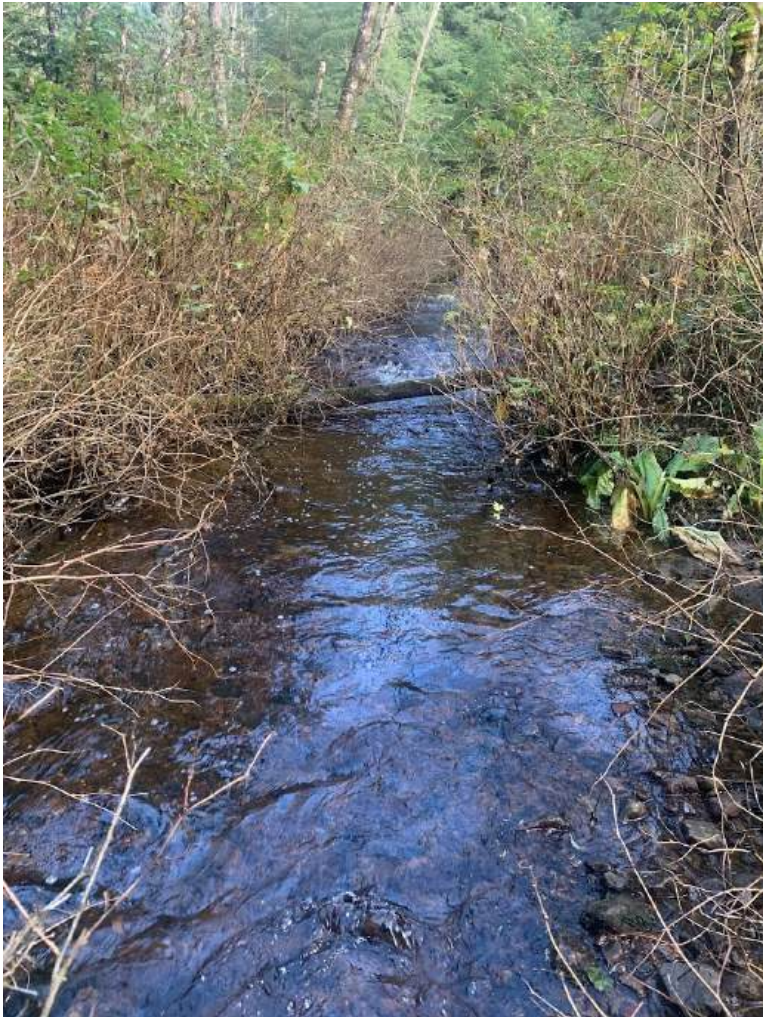
Photo 9 - Spawning habitat in Simoom Sound Creek.

- Good survey visibility throughout system.
- One coho seen in upper section of stream.
- Two trout encountered downstream of coho.

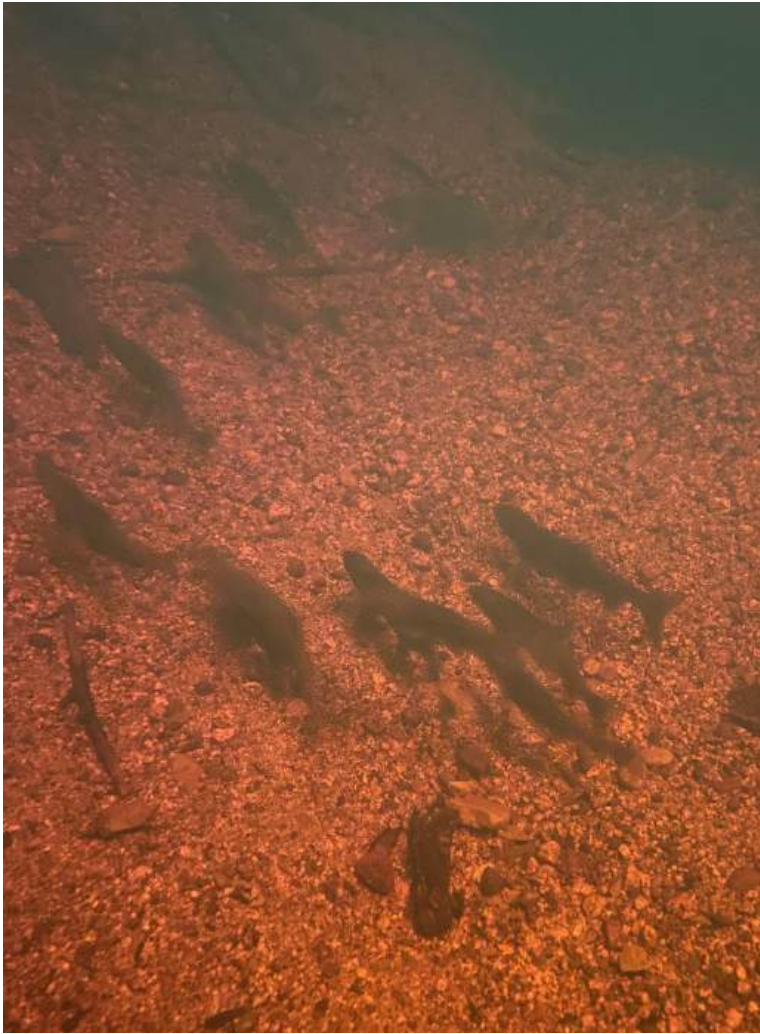
Photo 10 - Minihumps schooling and spawning in Minihump Creek.

- No minihumps seen in first 300m of stream.
- High concentrations of minihumps spawning from 300m upstream of Loose Lake to the falls on Minihump creek.
- One coho with a beat up tail seen spawning on gravel just below the falls on Minihump creek.
- Higher water than last rotation made for decreased surveyability and observer efficiency.

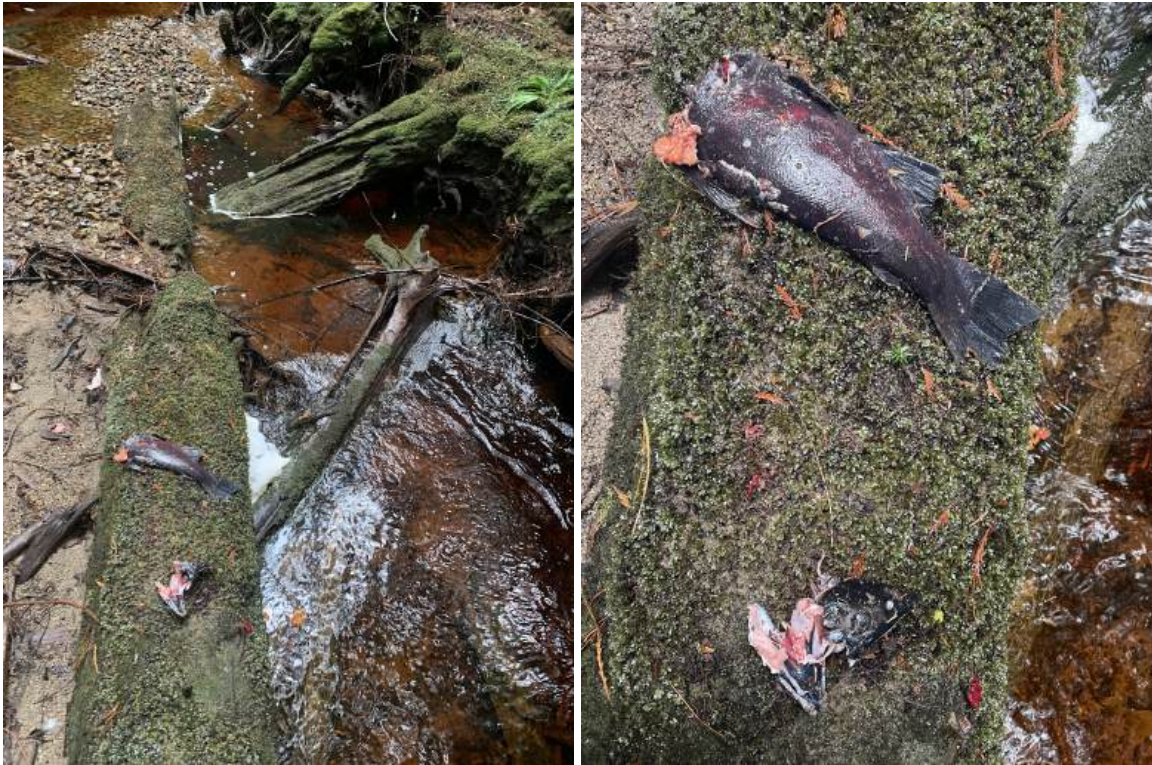
Photo 11 - Coho mort in Connector Creek, found shortly after bald eagle flew away.

- Jack coho seen at bottom of Connector creek where it meets Townee Lake.
- One pre spawn male mort found 200m upstream of road crossing. Likely killed by the eagle that was eating it.

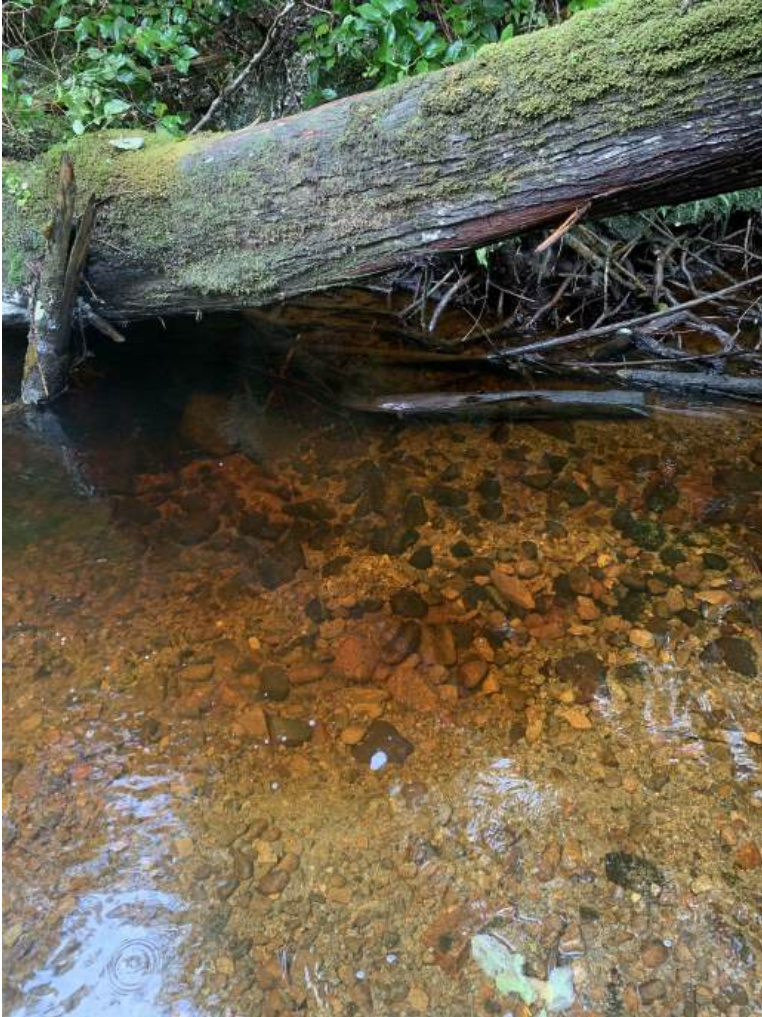
Photo 12 - Redds and test digs in Loose Creek where the two coho and a jack were seen spawning.

- Four coho and one jack seen spawning in left braid of stream. Two spawning groups, one being two adults and a jack, the other consisting of two adults.
- Multiple redds or test diggs seen near spawning coho.
- Loose lake backflooding the lower part of stream.

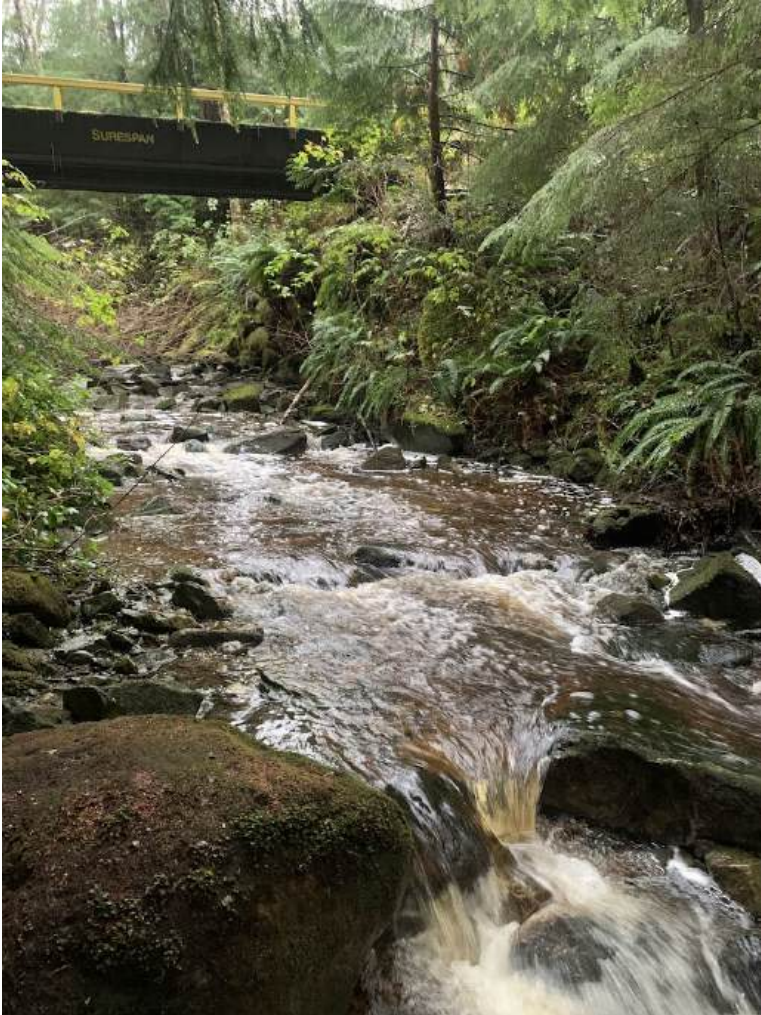
Photo 13 - John Lewis creek at the road crossing.

- No fish seen in system.
- 3 significant large straining log jams made up of small woody debris, likely impeding fish movement.
- Loose lake backflooding the lower part of stream.

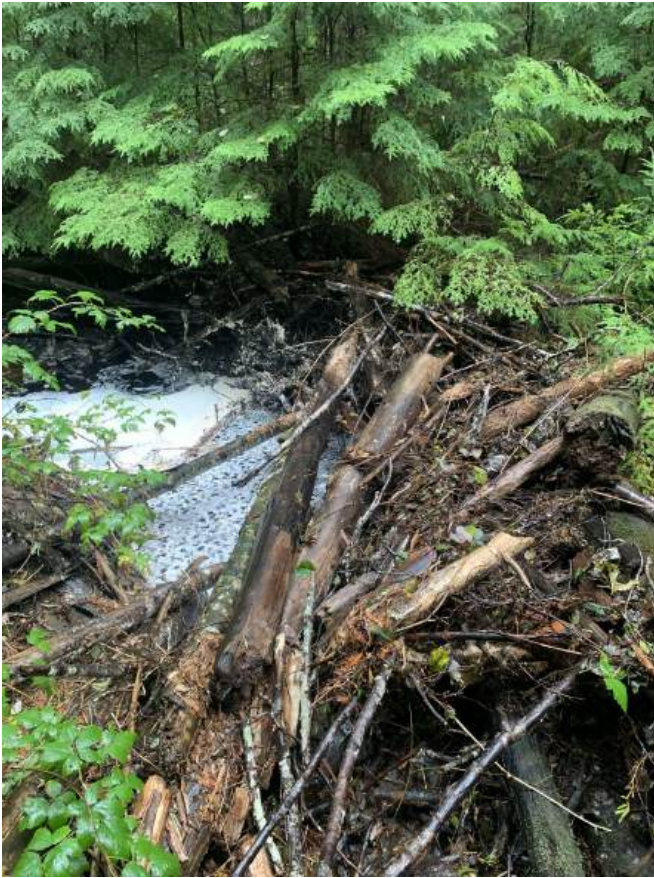
Photo 14 - One of the barriers to fish movement in Mt Worthington creek, this one being the lower of the two, located 150m upstream of the junction with Shoal Harbour Creek.

- No fish seen in the system.
- 2 blockages in the first 400m likely causing impediments to fish movement.
