Mainland Enhancement of Salmonoid Species Society

M.E.S.S.S. Report - Rotation 2
DFO Area 12 Stock Assessment 2024

Enumeration Period: August 27-31, 2024
Stream Technicians: Ian Clevenger, Abby Tinsley

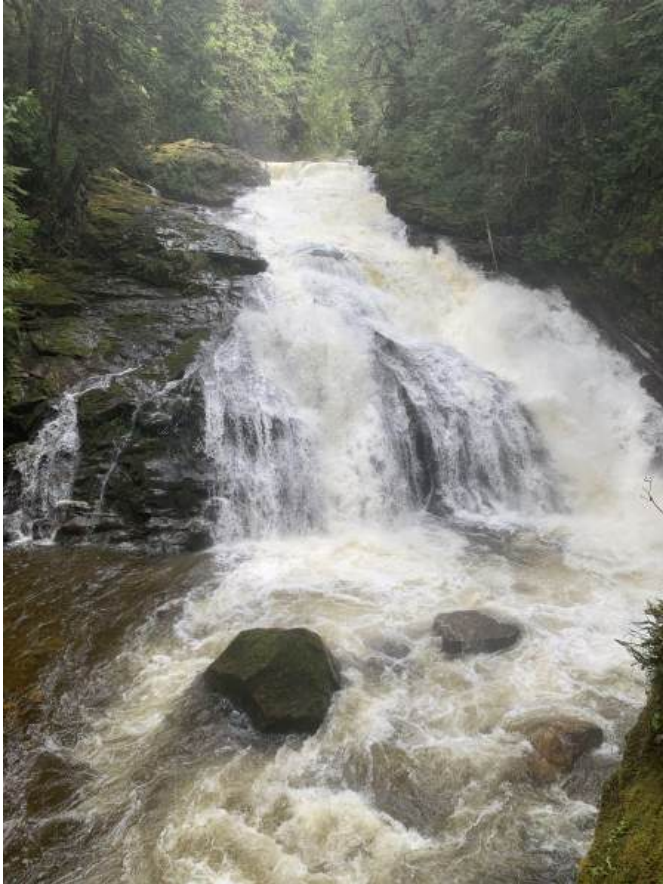
Photo 1 – High water at falls in

- The stream was difficult to survey due to high water levels after the rain event.
- Some sections were unsurveyable.
- Many places where salmon are typically seen were rapids, making it difficult to differentiate species.

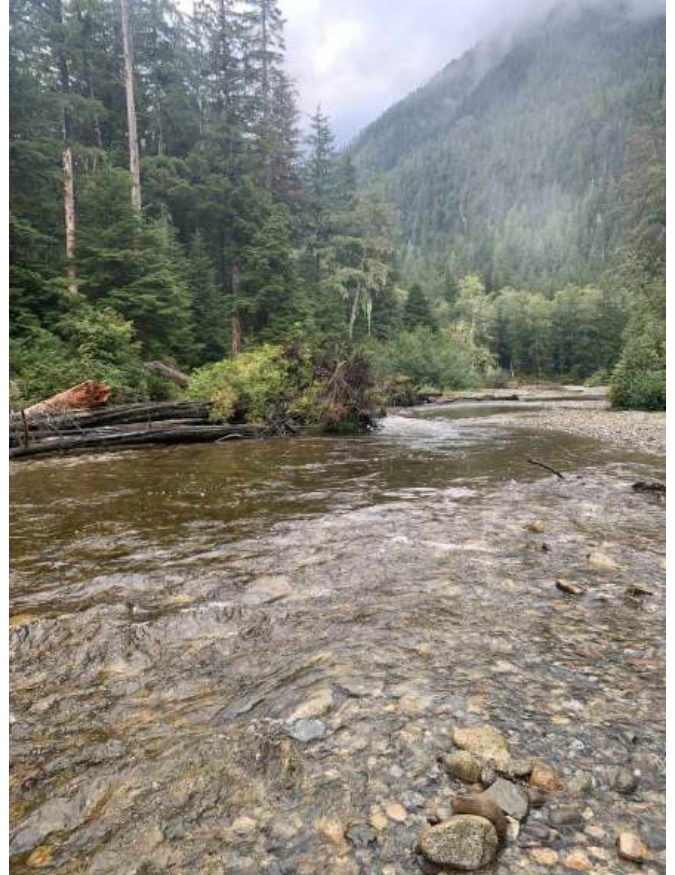
Photo 2 - Hada River above the log jam, looking upstream.

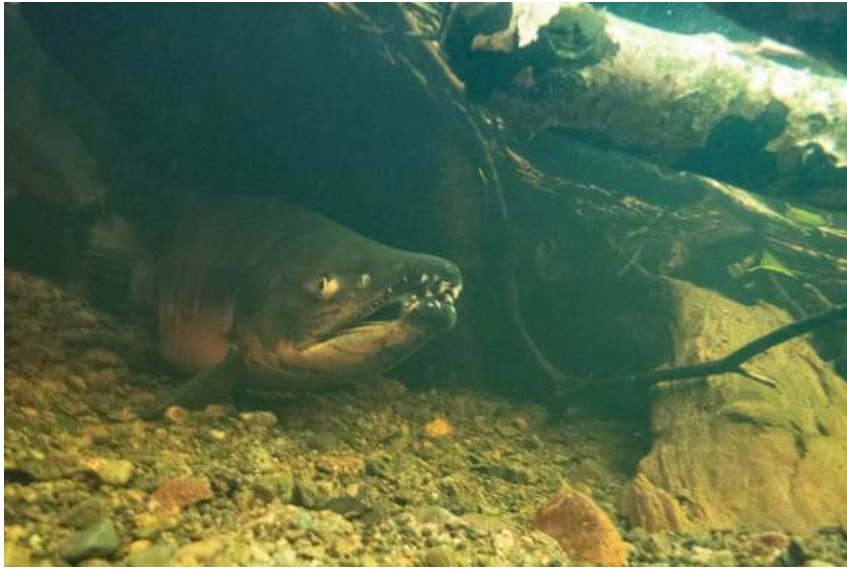
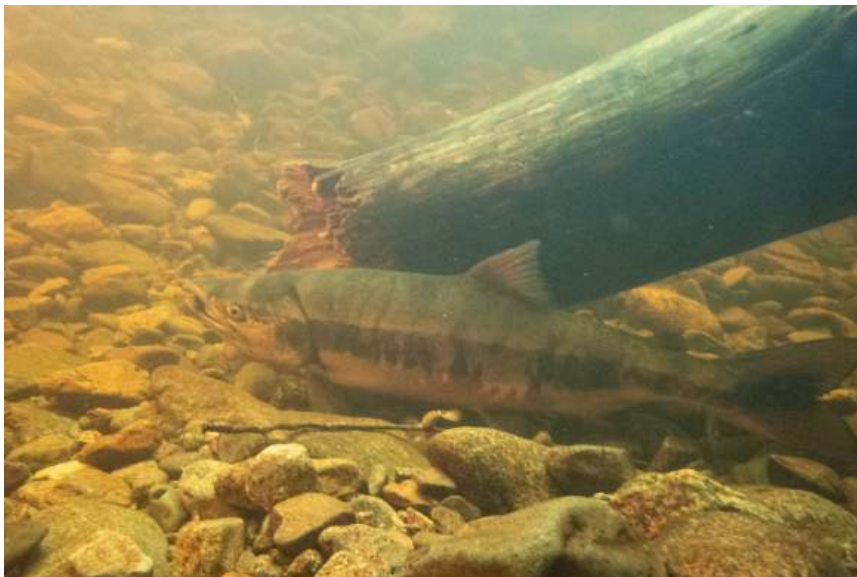
Photo 3 – A male and female chum, holding in Viner River, before spawning. Photos by R. Heschler.

- Pink redds seen, large amount appear to have spawned.
- Large increase in chum numbers, seen throughout first reach, at tributary pool.
- Many fish were seen holding in deep pools.

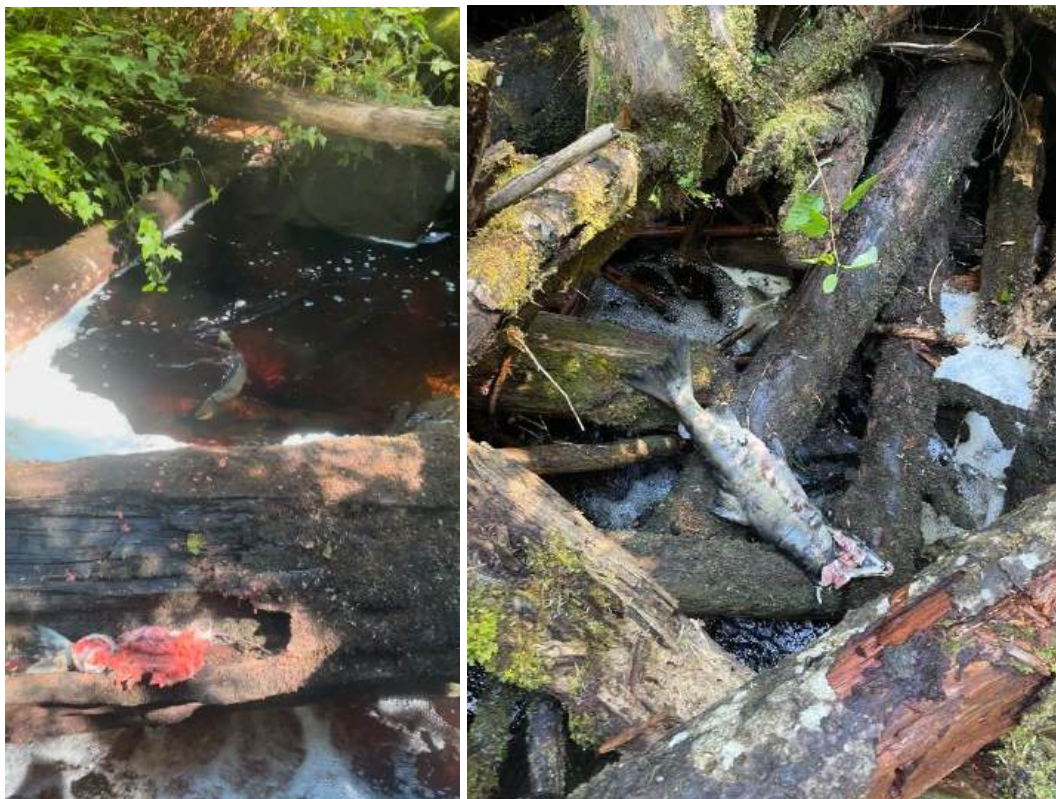
Photo 4- Chum morts in log jam in Shoal Harbour Creek.

- Large amounts of bear predation in areas with high chum concentration.
- Many chum stuck below major log jam, possible that chum may have restricted access to upper pools.
- Approximately five dead chum found in log jam, likely stuck in debris.

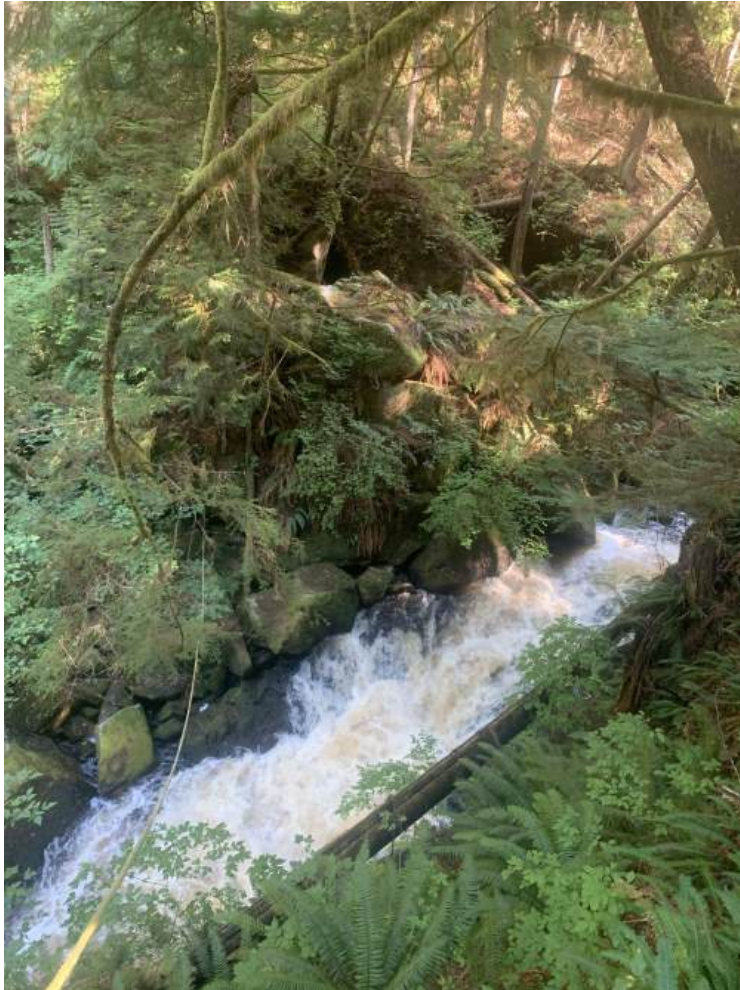
Photo 5– The lower falls at Scott Cove creek, formerly the broodstock pool, where many jumping coho were seen.

- Surveyed during heavy rain event.
- Unable to survey upper Scott Cove falls due to overgrown vegetation obstructing vision.
- The falls jumper count is more of a presence absence survey than a population estimate.

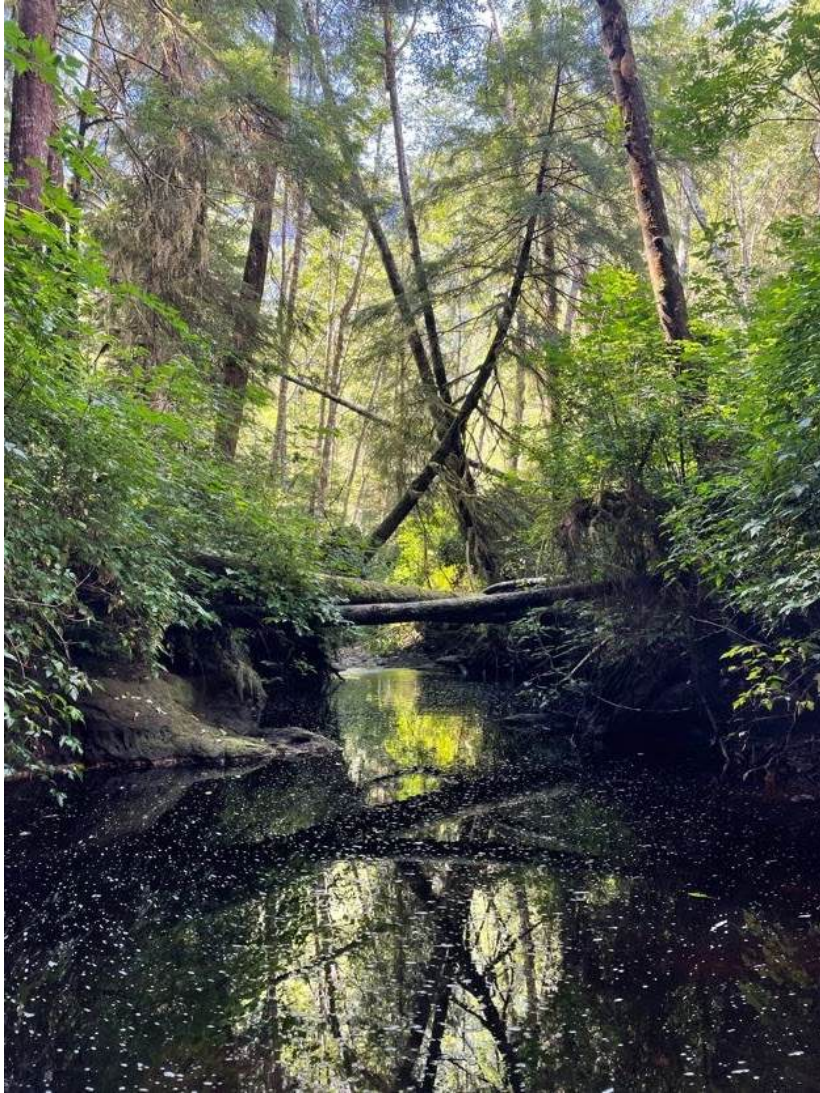
Photo 6 - Wahkana Creek with dark water and poor visibility.

- Dark water, poor visibility.
- Increased flow due to rain.

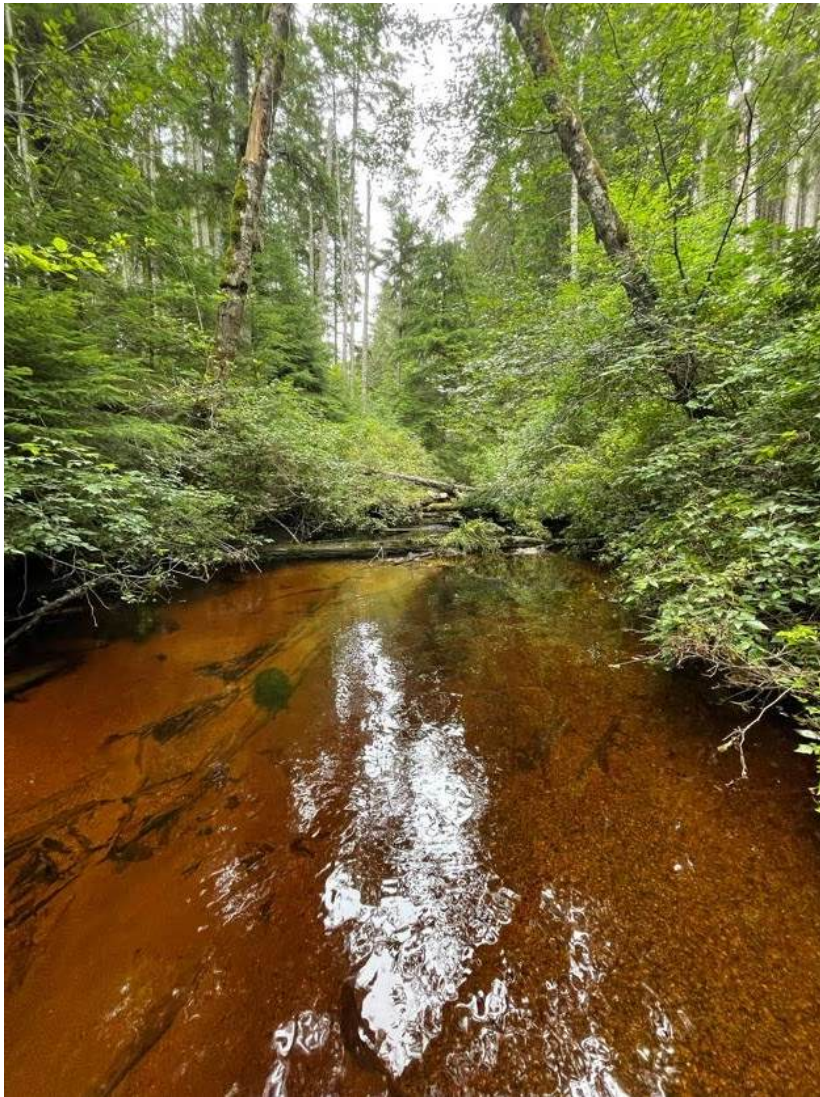
Photo 7 - Water levels in Maple Creek.

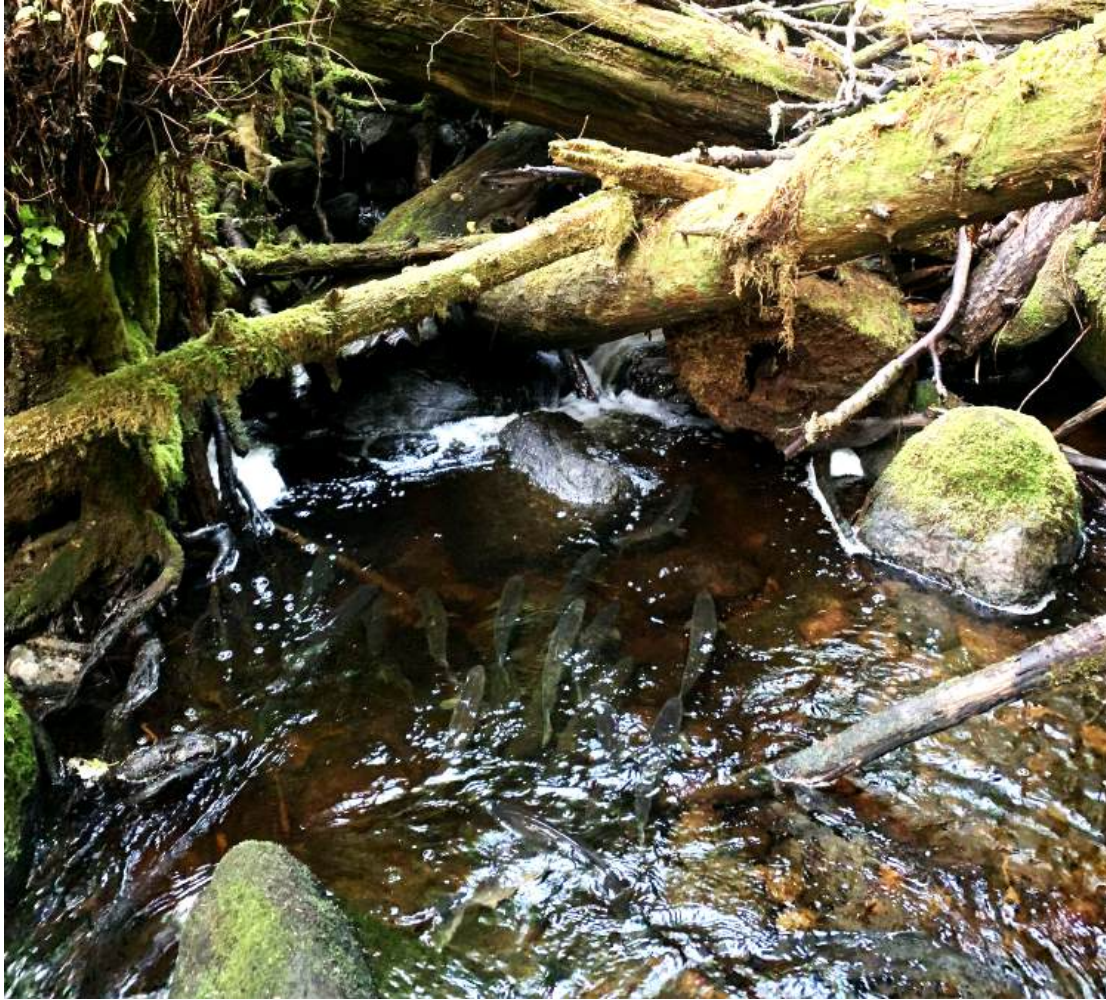
Photo 8 – Pinks seen holding below a stick jam. The jam was recently formed and partially cleared with intent for fish passage.

- First pinks seen since 2016
- Fish in first 100m of stream, holding below a stick jam (later cleared).

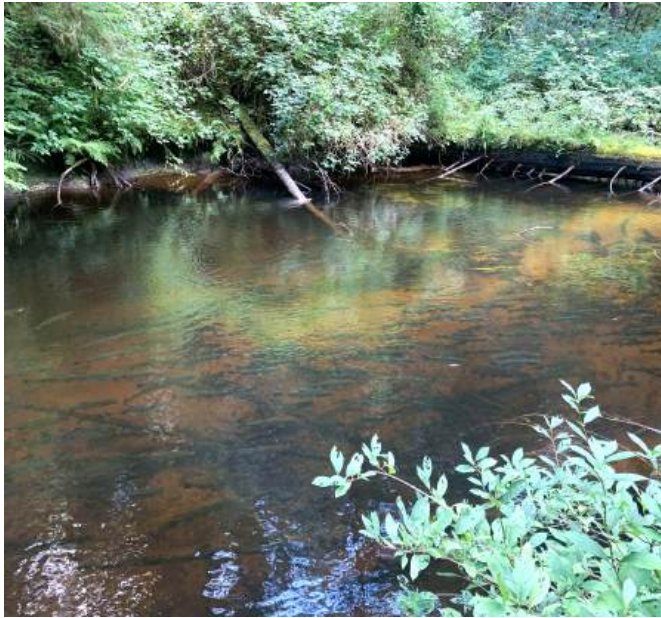
Photo 9- A pink salmon holding in the first reach of Embley River.

- Increase in total fish seen, large amount staging above fish ladder.
- Increased fish passage due to rains and increased stream flow.
- 283 pinks seen in second reach.
- Dark and poorly lit pools made estimation difficult.
